PORT REAL MARINA

103-50-10350
Name: Real Marina (North side right)
Latitude: 55°26'14" 17"
Longitude: 133°28'50" 55"
Geodetic Map No: Craig B5 (24)
Location: S shore of Lulu Island
1 mile W of the western tip of Pine Island

Catalog No: 103-50-85
Former Stream No: _____
Work Area: Ketchikan
Watershed Length: 0.75 miles
Drainage Area: 1 sq mi (polar pla.)
Water Supply Type: _____

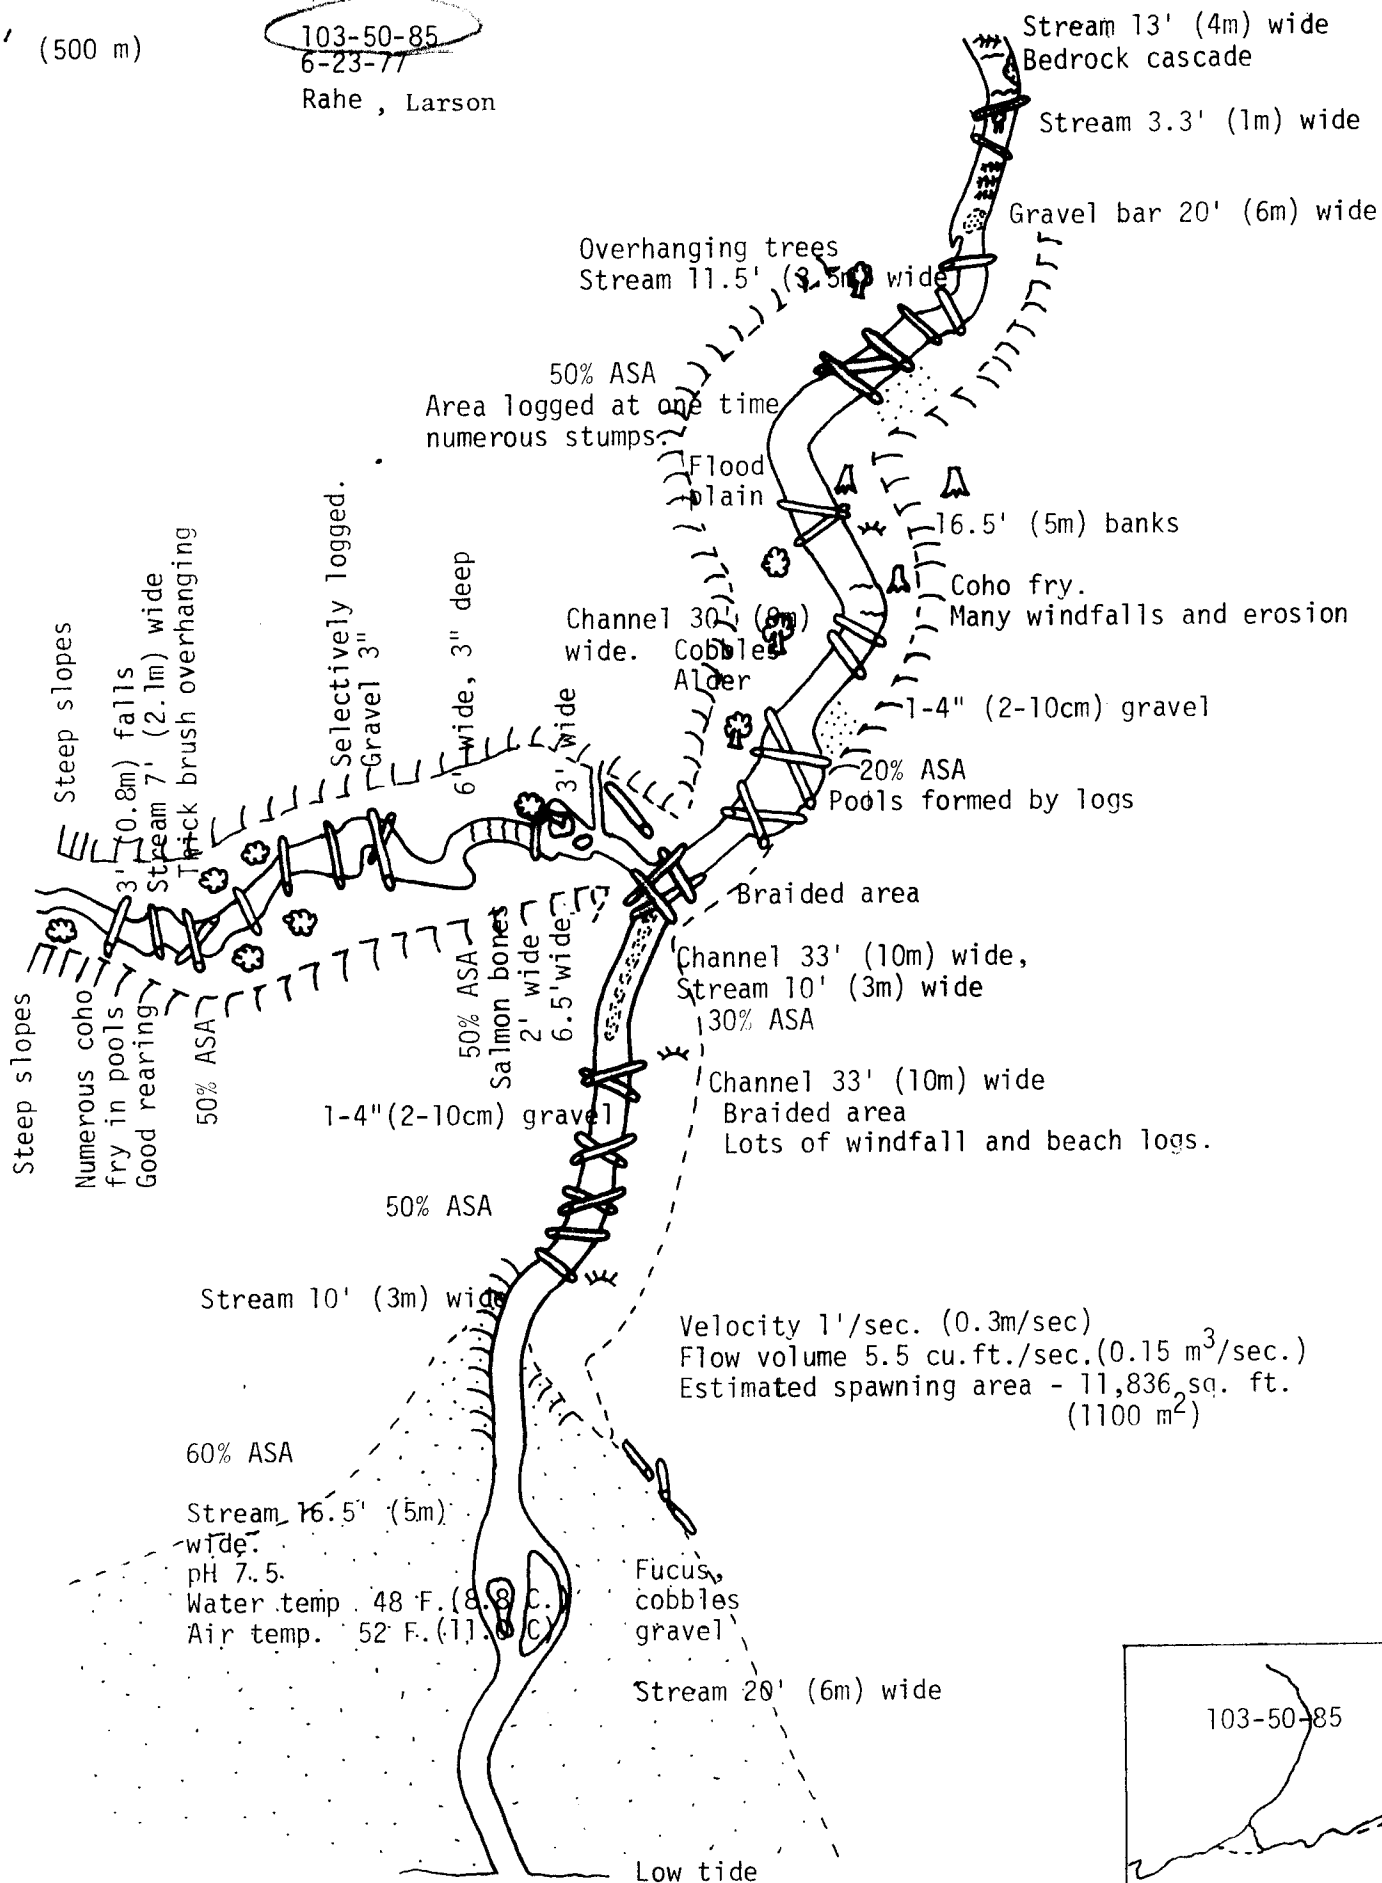
103-50-85

Spawning area: 1100m² (see map)

Spawning Areas: throughout the lower 1500'; scattered areas upstream

LAND USE (history, present, proposed): the stream banks have been extensively logged in the past (20+ years) in the lower 1600'; the resultant debris and disturbance are thought to have caused the extensive braiding and bank instability present in that area

SOILS: much of stream bed and banks are unstable in the area that was previously logged; numerous windfalls in the area

REHABILITATION POTENTIAL: the logs in the stream may have stabilized themselves; possibly removal would not be beneficial
